# Comparative Performance Analysis of AlTiN, TiAlN, and TiSiN Coated Ball Nose Mills in Machining Stavax ESR.

*Volume 9 Issue 2 – 2026 TALENTA Conference Series: Energy & Engineering (EE)*

Mohd Faizal Yasak, Ahmad Faiz Zubair*, Abdul Rahman Hemdi

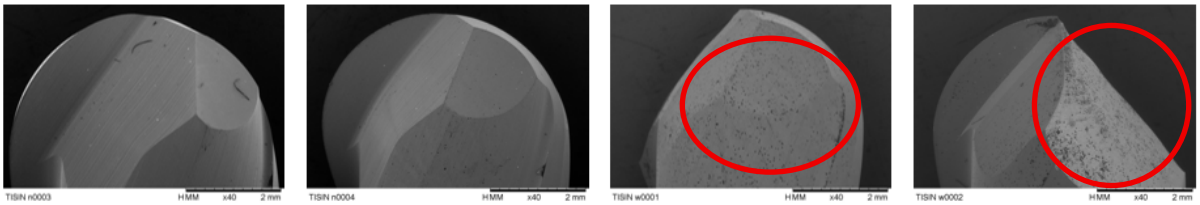
The surface of the 6 mm ball-nose end mills was analysed via SEM (x40 zoom) to evaluate the performance of AlTiN, TiAlN, and TiSiN coatings after machining Stavax ESR. Contrary to the theoretical high-hardness and advantages of nanocomposite structures, the TiSiN-coated tool presented the most severe degradation. The SEM images in Figure 4 clearly show catastrophic structural failure. The major fractured flute near the tooltip, exposing the underlying carbide substrate, suggests that the tool could not withstand the cyclic loads that existed in milling Stavax ESR.

a) New TiSiN side i b) New TiSiN side ii c) Used TiSiN side i d) Used TiSiN side ii

Figure 4. SEM image of the 6 mm TiSiN-coated ball nose end mill: (a,b) initial condition of the new cutting edges, and (c,d) observed major edge degradation shown in the red circle after machining Stavax ESR.

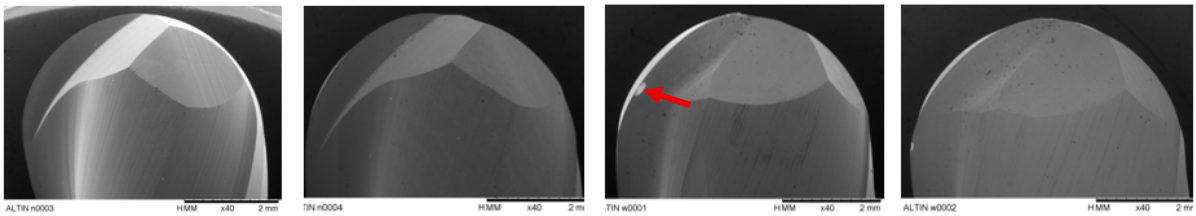
In contrast to the TiSiN tool, the AlTiN and TiAlN coatings demonstrated more stable and predictable wear behaviour. The AlTiN coating showed moderate abrasive wear and localised micro-chipping (Figure 5 c). While less durable than TiAlN, it maintained its structural integrity without the catastrophic fracturing observed in the TiSiN sample. TiAlN in Figure 6 displayed the highest resistance to edge degradation. The wear was characterised by minor abrasive marks, with almost no delamination of coating.

a) New AlTiN side i b) New AlTiN side ii c) Used AlTiN side i d) Used AlTiN side ii

Figure 5. SEM image of the 6 mm AlTiN-coated ball nose end mill: (a,b) initial condition of the new cutting edges, and (c,d) observed moderate edge degradation shown by the red arrow after machining Stavax ESR.

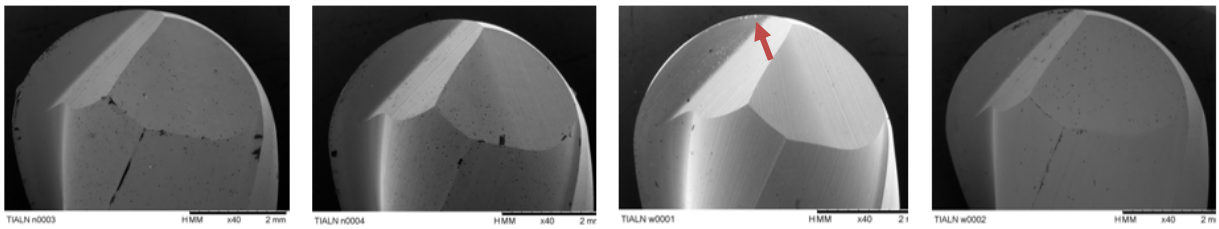
a) New TiAlN side i b) New TiAlN side ii c) Used TiAlN side i d) Used TiAlN side ii

Figure 6. SEM image of the 6 mm TiAlN-coated ball nose end mill: (a,b) initial condition of the new cutting edges, and (c,d) observed minor degradation shown by the red arrow after machining Stavax ESR.
